# Microscopic topography of ultrasound probes: implications for high-level disinfection and infection control

This descriptive study evaluated the microscopic topography of endocavity and surface ultrasound probes using scanning electron microscopy (SEM) to assess their potential to harbour microorganisms of varying size.

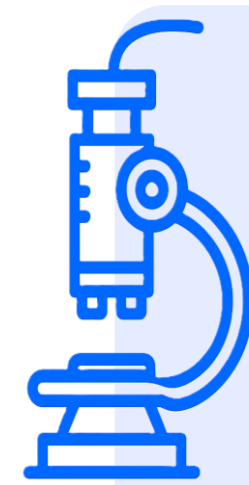
- **46 sites** over **15 probe segments** were imaged using SEM without **conductive coating**.
- **Widths** of seams, crevices, and gaps were **estimated using the scale bar** in each SEM image.
